# Inspection Report

3211 Main St  
Small Town, CA  
92008

**JT Construction Products, LLC**

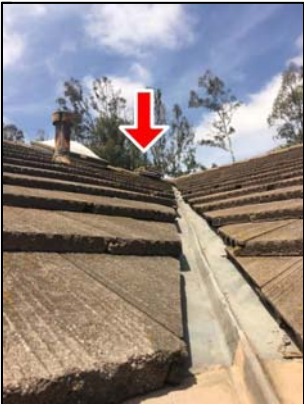
1.0 Item 1(Picture)

(2) Excess tiles piled on roof. Recommend removing tiles.

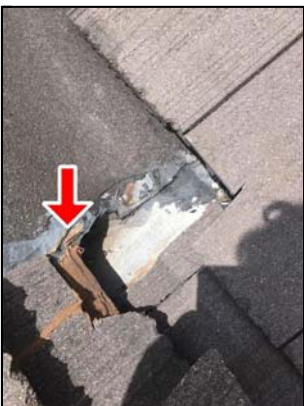
1.1 Item 1(Picture)

(2) Grout Flashing repair noted. Recommend monitoring roof for signs of deterioration or water damage.

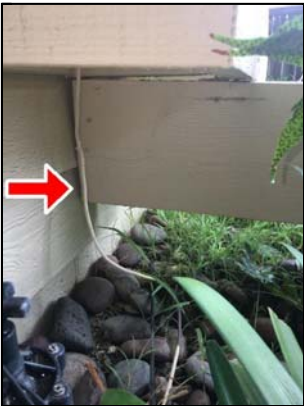
2.3 Item 1(Picture)

(2) Support for window box loose deteriorated. Recommend repair/replace as necessary.

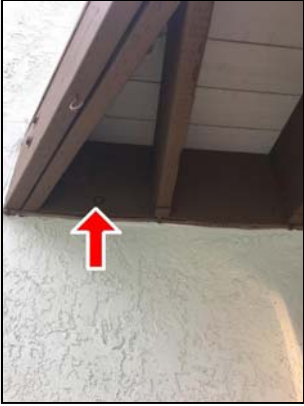
2.3 Item 2(Picture)

(3) Deck ledger not properly fastened (per recent code). No flashing visible between house and deck. Recommend buyer have licensed contractor evaluate and repair/replace as necessary as upgrade.

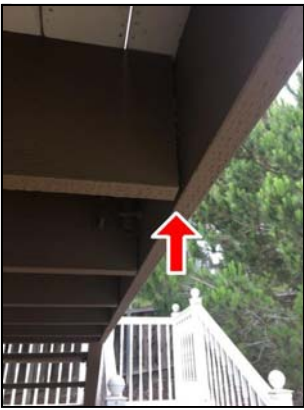
2.3 Item 3(Picture)

(4) Deck cantilever joist not correctly fastened with joist hangers. Pulling away from rim joist. Recommend installing proper joist hangers.

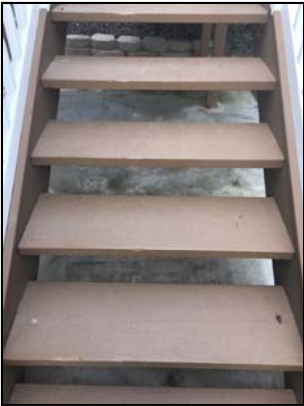
2.3 Item 4(Picture)

(5) Deck handrail wobbly. No backing on stair treads. Recommend licensed contractor evaluate and repair/replace as necessary.

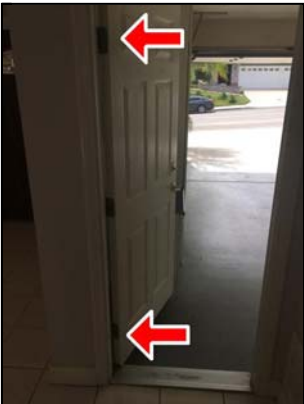
3.4 Item 1(Picture)

(2) Fire door does not auto close and latch. Recommend repair/replace hinges as necessary.

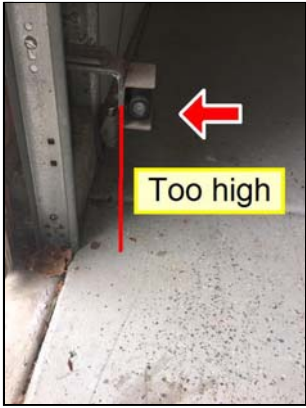
3.5 Item 1(Picture)

(2) Electric eye above 6 inches. Recommend lowering electric eye no more than 6 inches above garage floor.

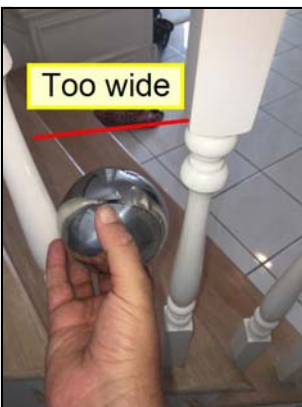
4.3 Item 1(Picture)

(2) Stair banister spacing exceeds 4 3/8. Recommend repair/replace as necessary.

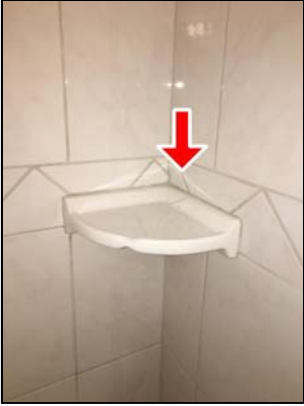
4.4 Item 1(Picture)

(2) Soap dish first floor bath cracked and loose. recommend repair/replace as necessary.

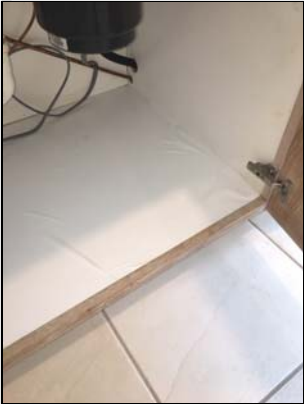
4.4 Item 2(Picture)

(3) Water damage to laminate under kitchen sink. Recommend repair/replace as necessary.

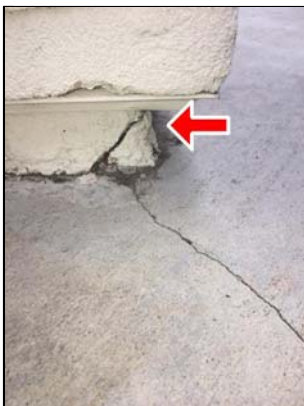
5.0 Item 1(Picture)

(2) Foundation corner crack under patio. Recommend monitor crack for further movement or have structural engineer evaluate.

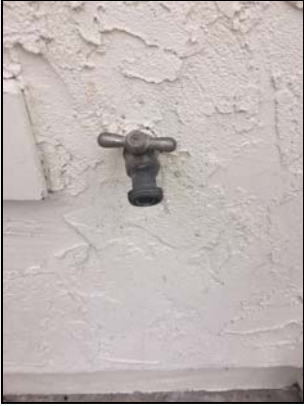
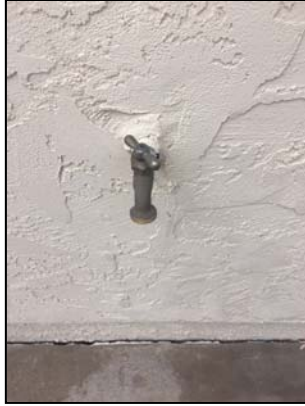
(2) No anti-siphon device spout side of garage. Recommend installing anti-siphon device to ensure no cross connection contamination of interior water.

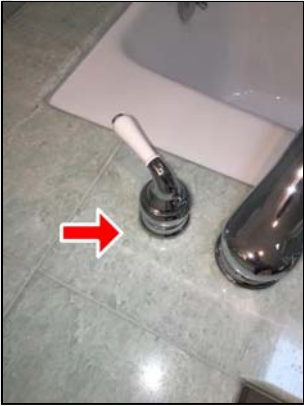
6.1 Item 4(Picture)

(3) Master tub cold water knob loose at base. Recommend repair/replace as necessary.

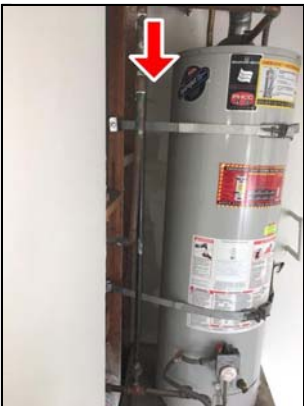
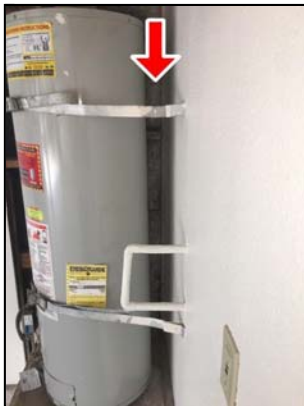
(2) Hot water heater not solidly blocked. Straps loose. Recommend repair/replace as necessary to ensure water heater firmly secured.

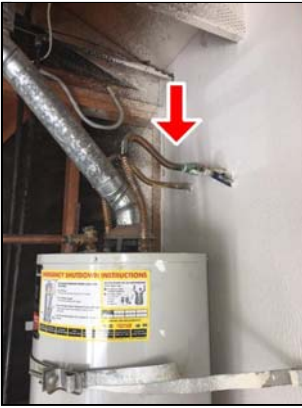
6.3 Item 3(Picture)

(3) Water heater pipes not insulated. recommend insulating pipes as upgrade to increase energy efficiency.

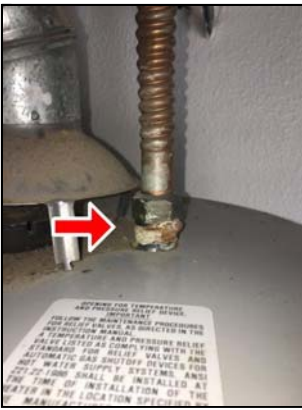
6.3 Item 4(Picture)

(4) Non-dialectic fittings causing corrosion. Recommend licensed plumber evaluate and replace as necessary to increase life of water heater.

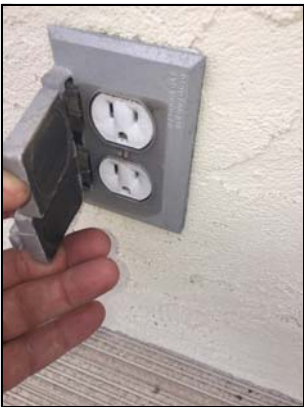
7.5 Item 1(Picture)

(2) Exterior deck outlet not GFCI. Recommend replace with GFCI as upgrade to enhance safety of house.

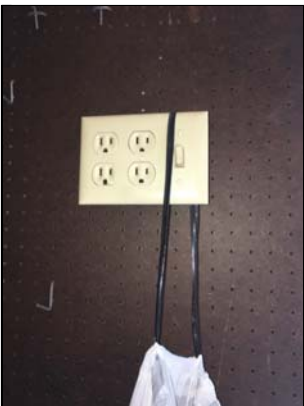
7.5 Item 2(Picture)

(3) Garage outlets not GFCI. Recommend replace with GFCI to enhance safety of house.

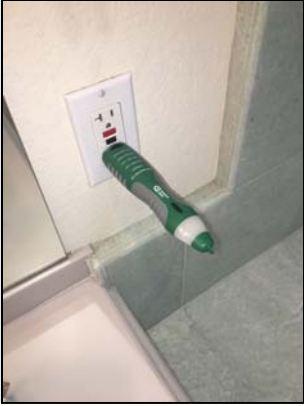
7.5 Item 3(Picture)

(4) GFCI by tub in master bathroom inoperable. Recommend repair/replace as necessary.

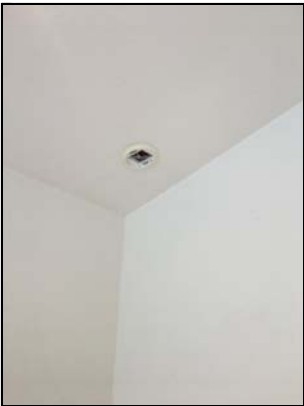
7.7 Item 1(Picture)

(2) Missing smoke detector master bedroom. Recommend replacing smoke detectors to enhance safety of house.

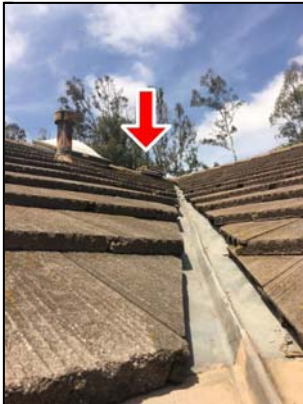
1.0 Item 1(Picture)

(2) Excess tiles piled on roof. Recommend removing tiles.

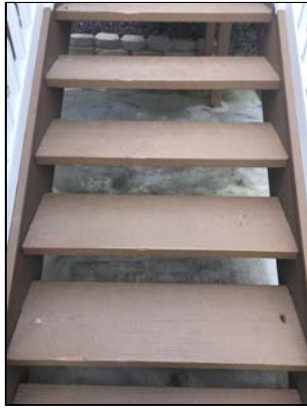
2.3 Item 4(Picture)

(5) Deck handrail wobbly. No backing on stair treads. Recommend licensed contractor evaluate and repair/replace as necessary.

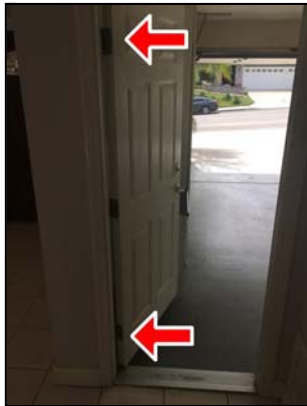
3.4 Item 1(Picture)

(2) Fire door does not auto close and latch. Recommend repair/replace hinges as necessary.

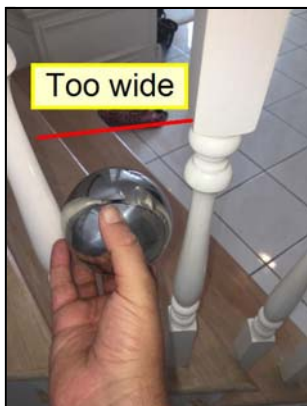
4.3 Item 1(Picture)

(2) Stair banister spacing exceeds 4 3/8. Recommend repair/replace as necessary.

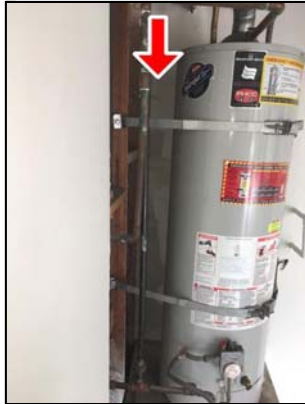
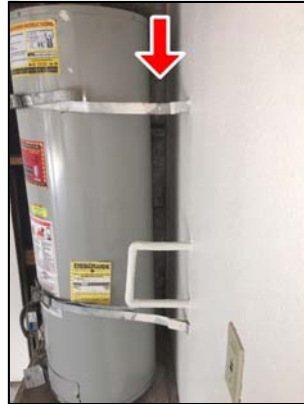
(2) Hot water heater not solidly blocked. Straps loose. Recommend repair/replace as necessary to ensure water heater firmly secured.
